**COMPREHENSIVE GROUND-WATER MONITORING EVALUATION
CME - 08**

RAYMARK INDUSTRIES

PAD003015328

TITLE: CME - 08

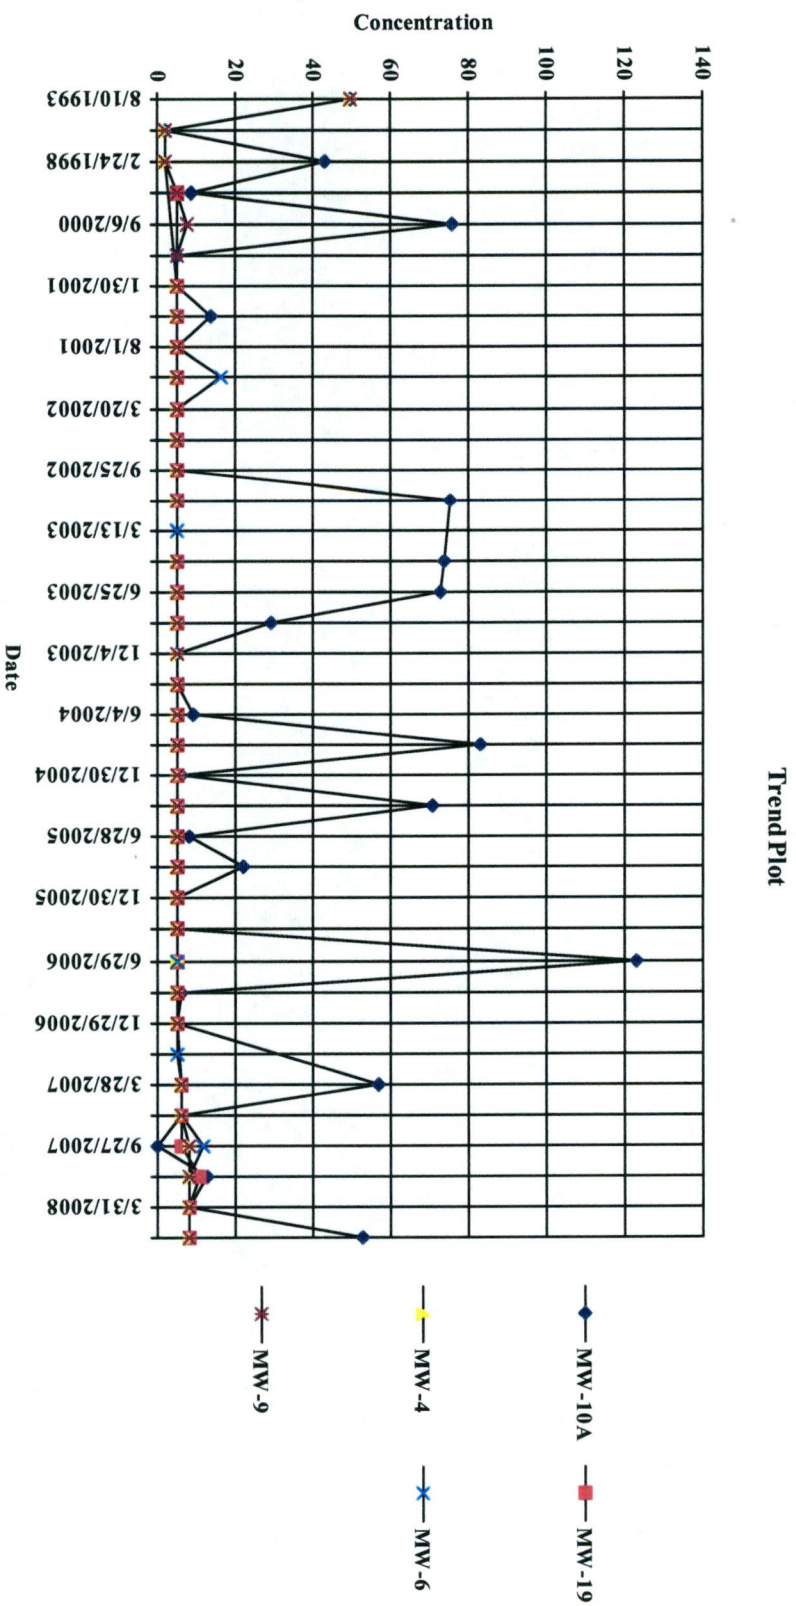
Trend Plot For: LEAD; DISSOLVED (ug/l)

A tabular comparison of laboratory sample results shows little disparity in the analytical reports with the exception of dissolved lead at well MW-10A. The Department's sample result for dissolved lead at MW-10A was Non-Detect at 1 ug/l while that of the consultant was 53 ug/l. The total lead results were comparable at 49.3 ug/l for the Department and 45 ug/l for ALSI. The trend plot for dissolved lead, along with other parameter trend plots is presented in Appendix A. The data for dissolved lead at well MW-10A should be considered suspect. The similarity between results for total (45 ug/l) and dissolved (53 ug/l) lead reported by ALSI leads to the suspicion that a filtered aliquot was not analyzed. For all other analytical parameters the results from ALSI and the Department's analytical laboratory are comparable. Overall the sample results are reasonable and appear accurate.

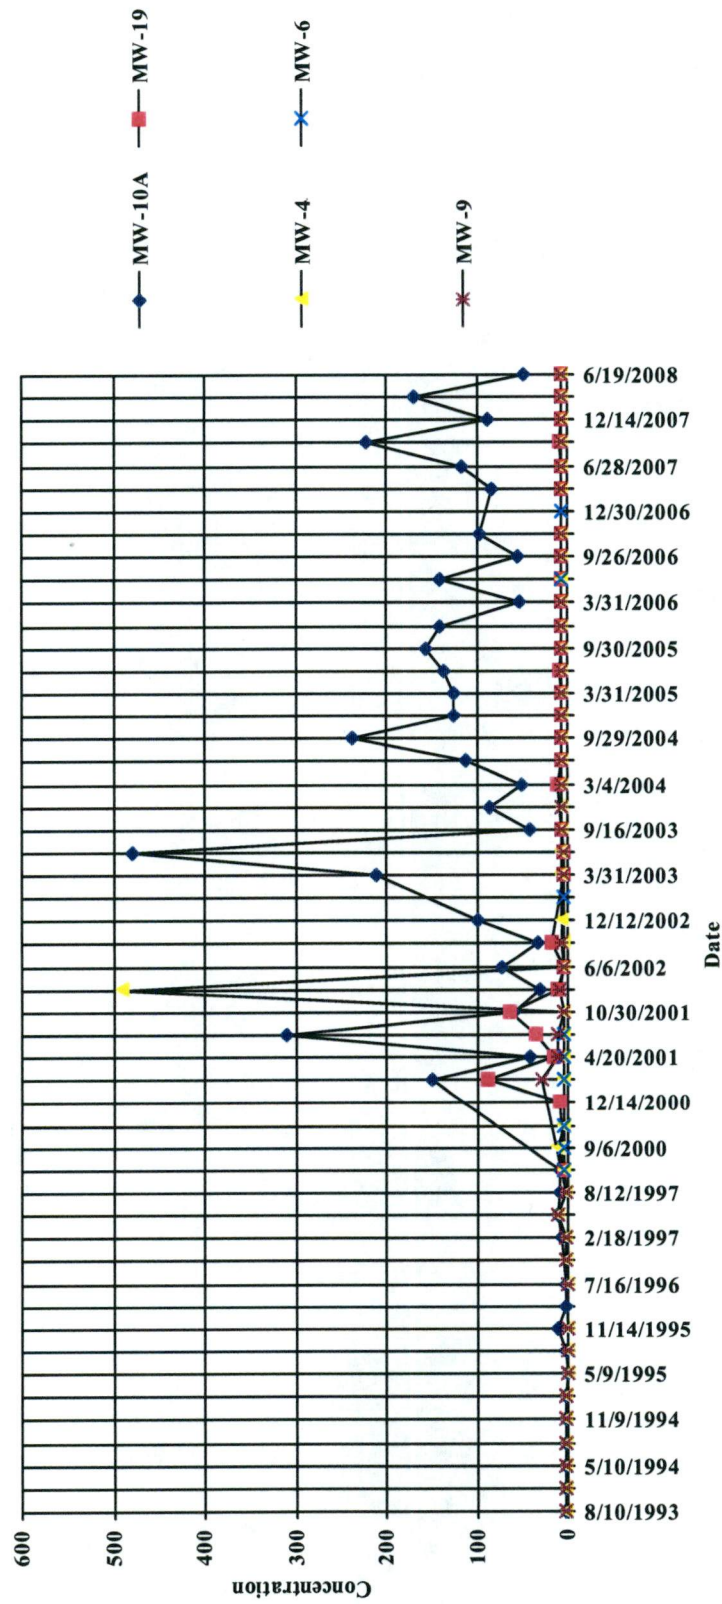
Trend Plot For: LEAD; TOTAL (ug/l)

The Parameter trend plots (included in Appendix A) illustrate the concentration and relative changes in parameter values over time. In general values had been decreasing with time since the landfill was closed. This indicates that the landfill closure, while not, “state of the art” has been effective in reducing the level of indicator parameters released to the environment. A review of the updated trend plots shows an apparent increasing trend in the concentrations of Alkalinity (wells MW-10A, MW-19), Chloride (wells MW-10A, MW-6), and Sulfate (wells MW-6, MW-10A and MW-19). Lead, the hazardous material for which the site was originally listed, has not been seen in groundwater with any regularity, even when the site was active. Well MW-10A is the exception, however. Since the third

quarter or 2002, total lead has been regularly detected ranging from approximately 25 ug/l to over 500 ug/l. Dissolved lead has also been detected with some regularity in well MW-10A.

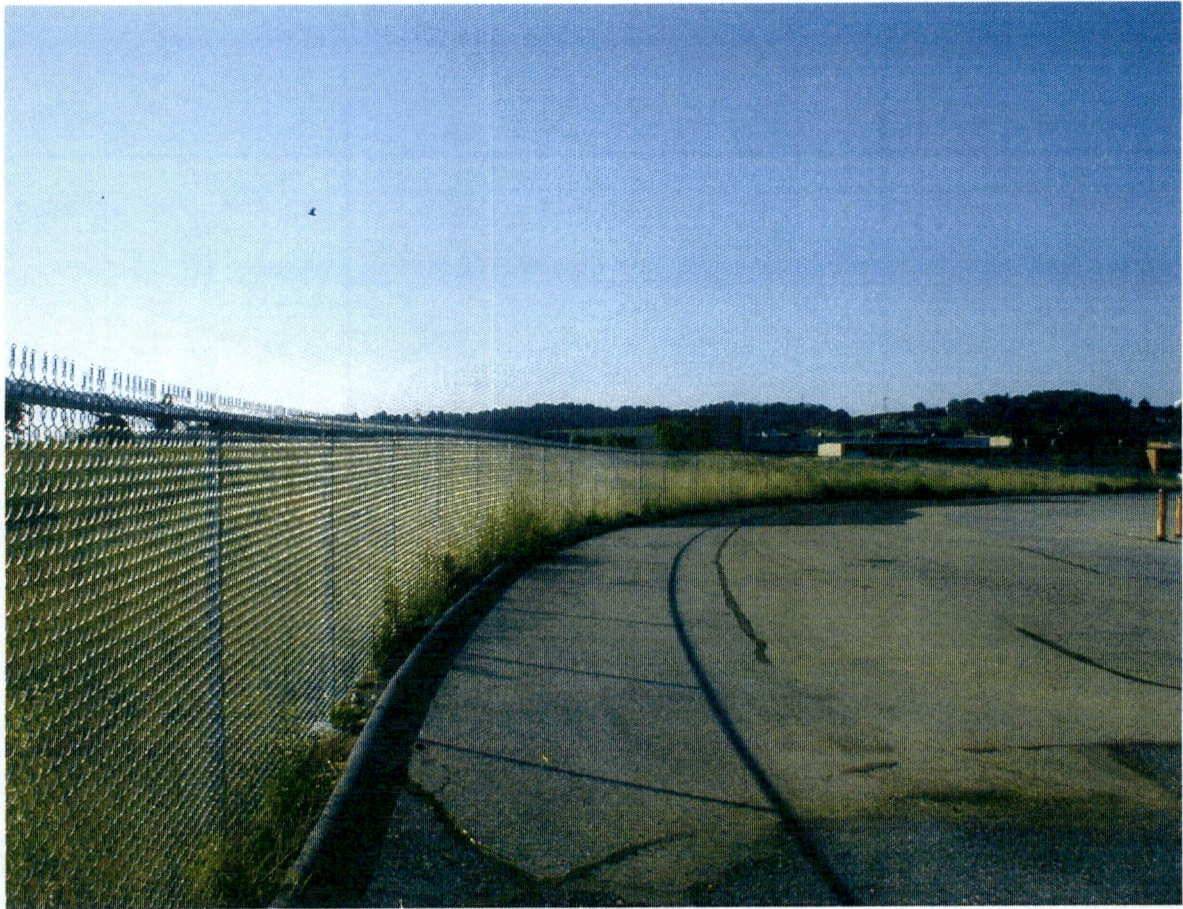
06/19/08 New Fence-View South.

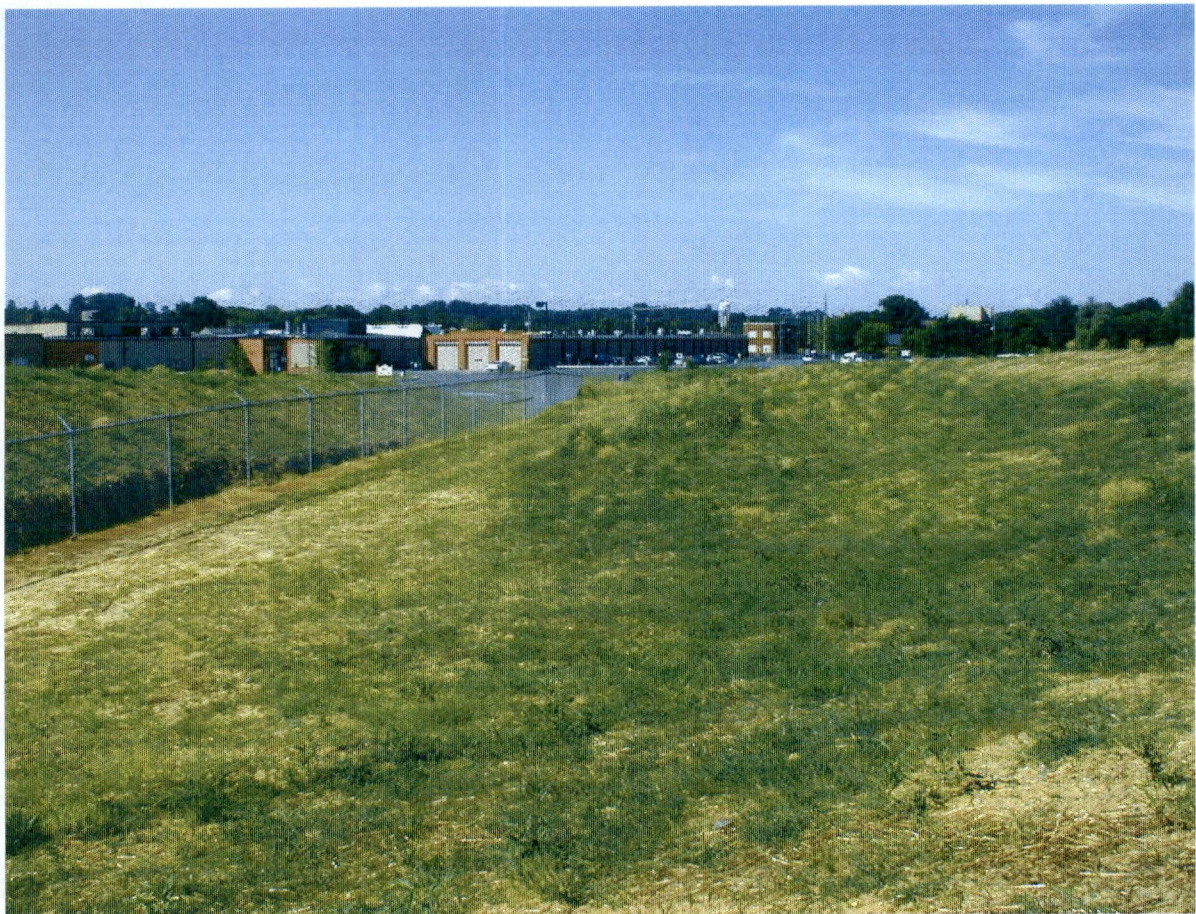
06/19/2008 New Fence-View SW.

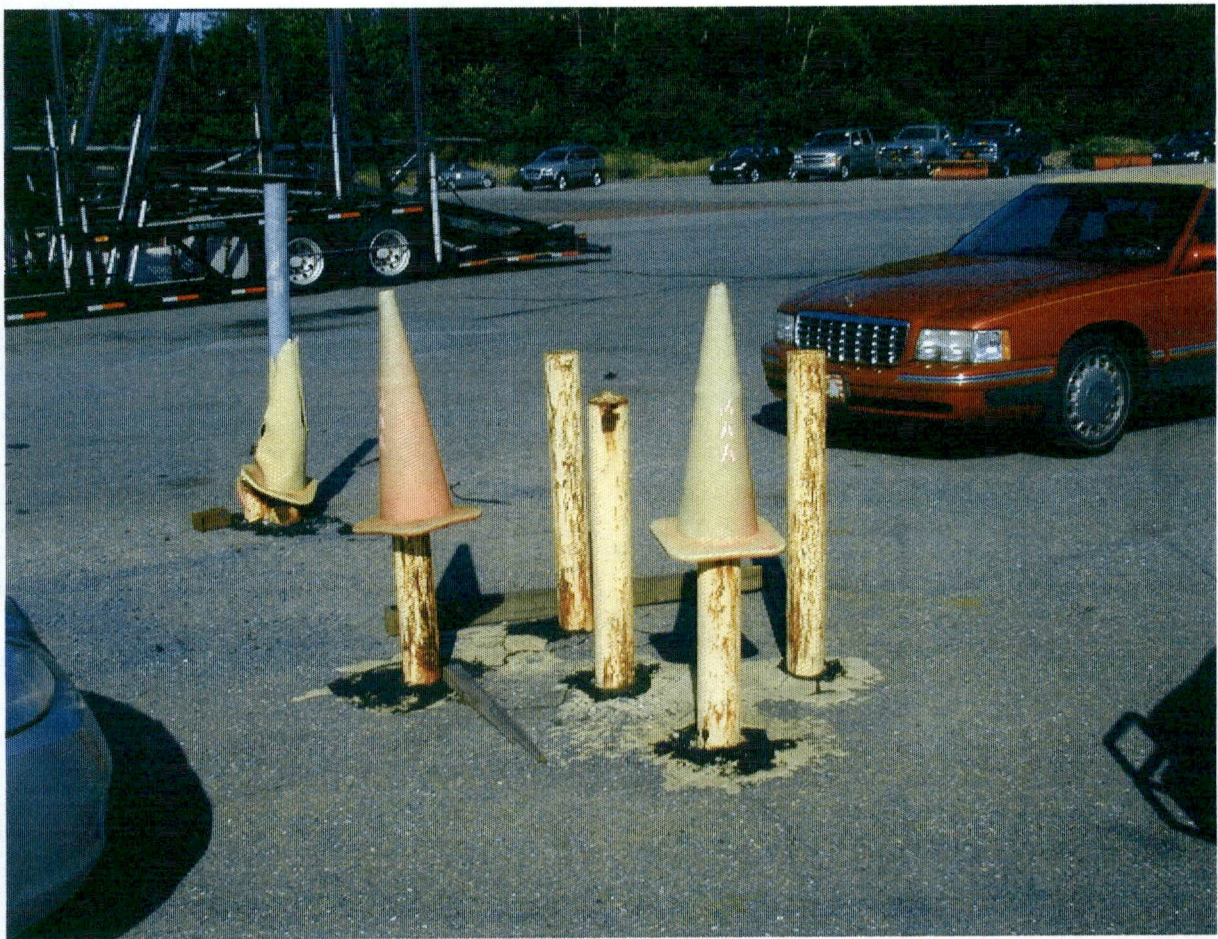
06/19/2008 Unused well cluster.

- Locate and identify wells drilled at the landfill. Wells that are no longer useful should be properly abandoned by a professional well driller. Please consult with the Department before removing wells to make sure that they are no longer required. A well abandonment report must be filed with the Department of Conservation and Natural Resources, Bureau of Topographic and Geologic Survey at the completion of this work. I can provide guidance if your driller is unfamiliar with this requirement.
- Repair the caps and locking mechanism for all wells that are not abandoned. Monitoring wells should be securely locked at all times except during sampling.
- Remove unwanted vegetation and dead fall trees that make access to the monitoring wells difficult.
- Make certain that your groundwater sampling consultant follows the appropriate sampling protocol when taking samples for analysis.

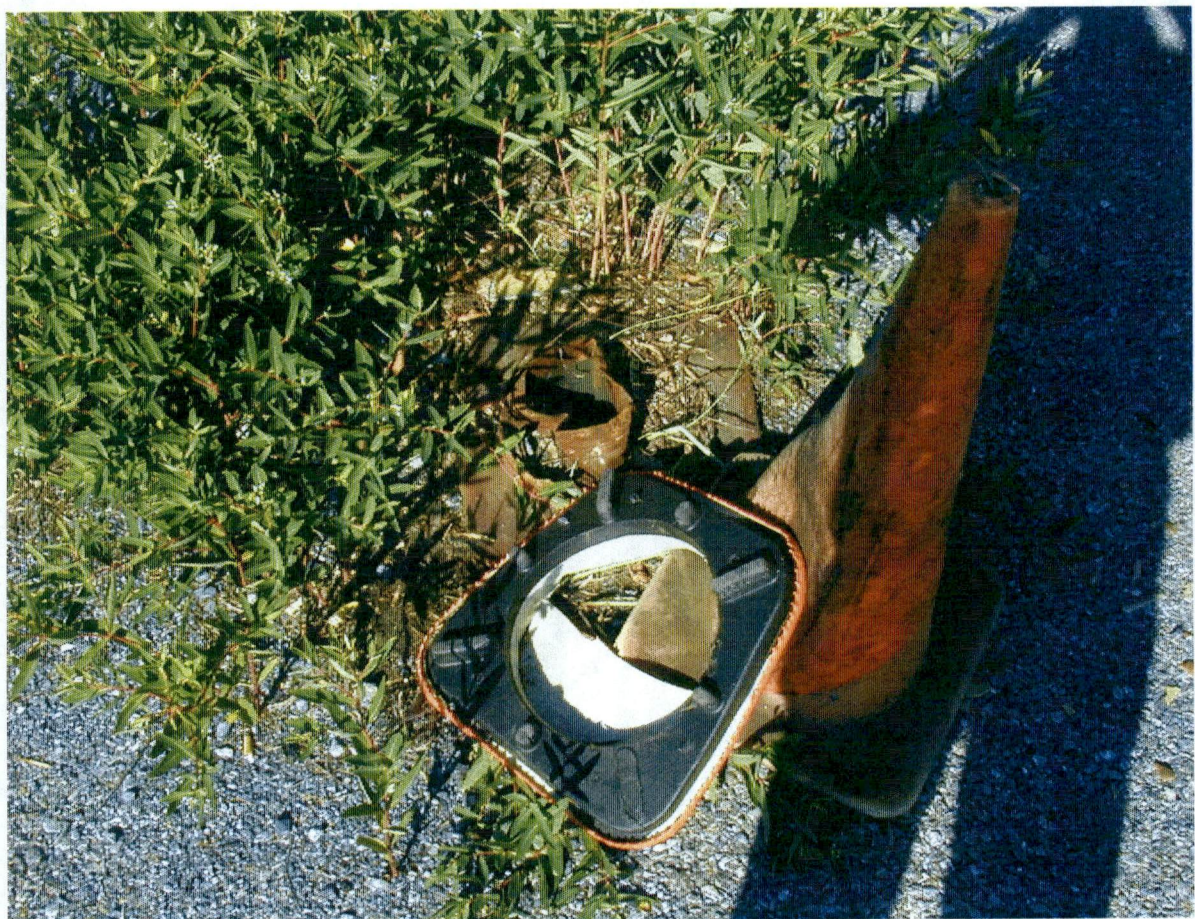
06/19/2008 Broken well on paved landfill surface.

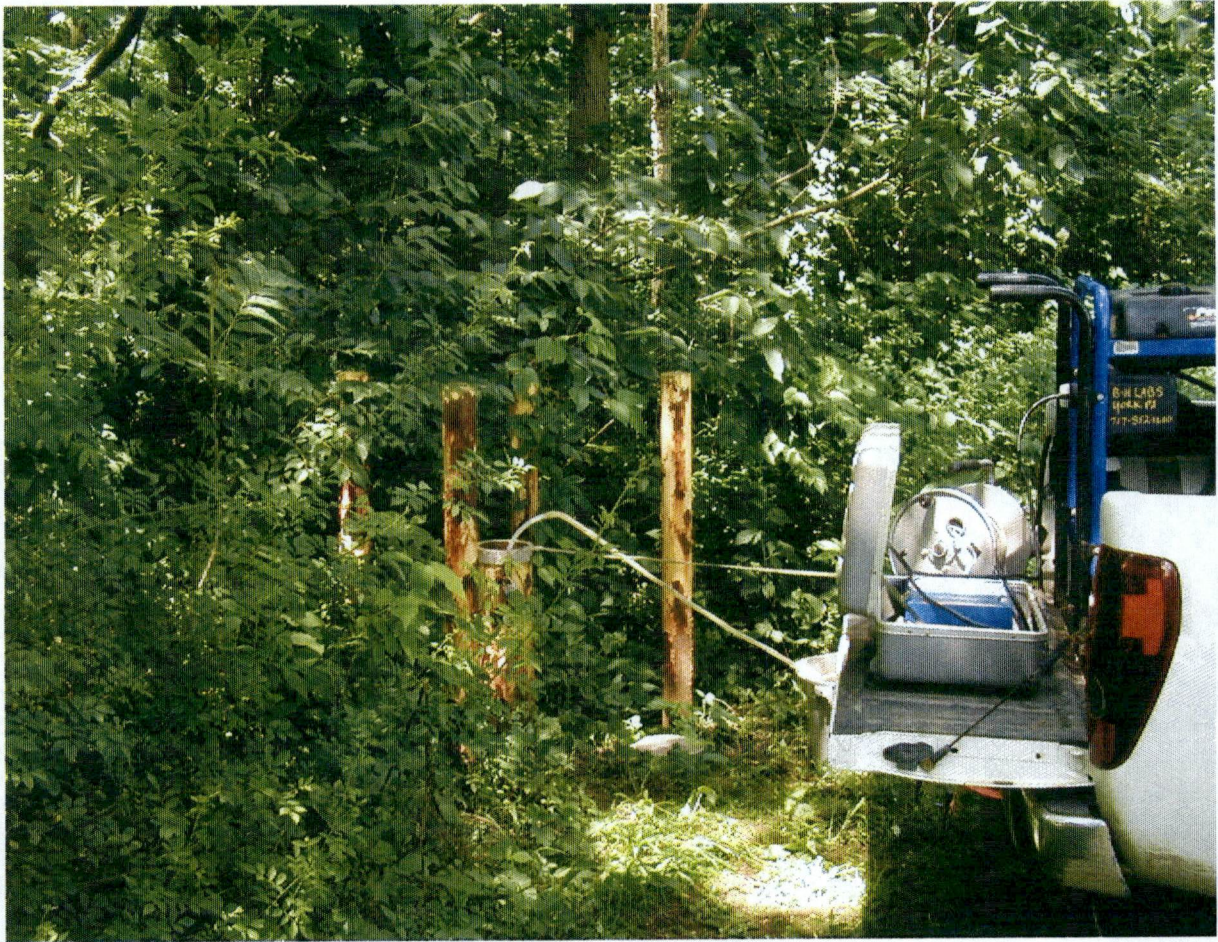
Well MW-9 is the background well for this site. The well is located in poorly drained, mosquito infested woodland to the North of the landfill. Revised drainage for the landfill closure resulted in asphalt curbing and a storm water inlet box that obstructed access to the roadway. High clearance vehicles with four wheel drive capability are definitely recommended for sampling this well. The roadway had been recently cleared of ground vegetation, but several fallen trees made the roadway nearly impassable. Downgradient wells are MW-4, MW-6, MW-10A and MW-19.

06/19/2008 Purging MW-9, upgradient well.

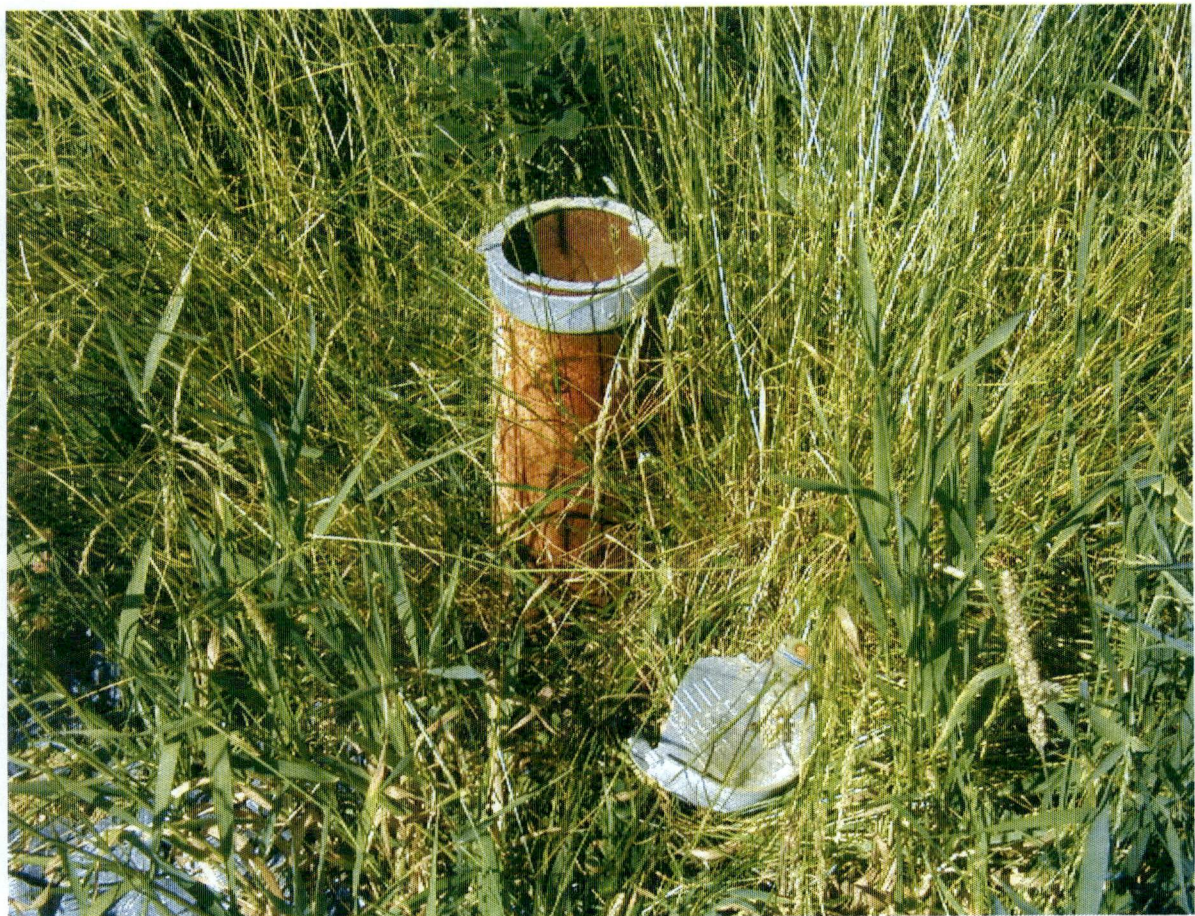
operator due to the risk of collision with vehicles and a risk to groundwater if automotive fluids leaked and reached a well with no cap. This condition also presents a vandalism opportunity. Wells MW-19 and well MW-6 have damaged caps that cannot be secured. Several of the wells were not locked. Vegetation in the vicinity of wells MW-6 and MW-10A should be thinned or mowed in order to make sampling more pleasant and eliminate a risk from poison ivy and ticks. In a letter dated August 22, 2008, this author made several recommendations in this regard for the improvement of the landfill cover and sampling integrity at the Upper Mill Landfill. This letter was sent to Lot 5 Associates even though the transfer of the property has not been completed to the date of this writing, and a copy also sent to Phoenix Resources LLC. An additional copy of the letter appears in Appendix C of this report.

06/19/2008 Well MW-19, cap broken

Wells MW-19 and MW-6 are two of the monitoring points that require sampling during the Post Closure Care period of the landfill. The caps and locks are broken on both of these wells leaving them vulnerable to vandalism and contamination. New caps with appropriate locking hasps should be installed and these wells along with all other wells that are not abandoned should be locked.

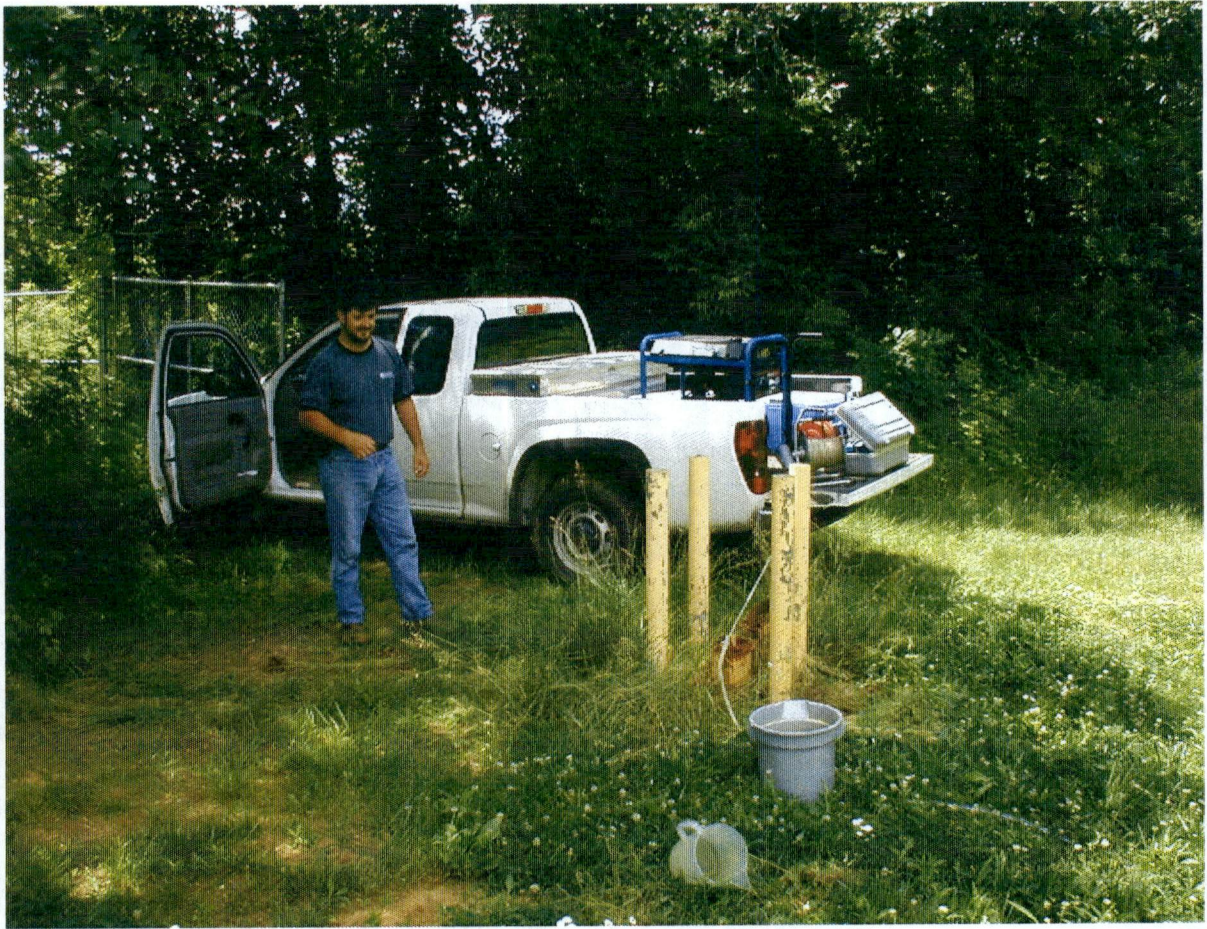
06/19/2008 Analytical lab sampler at MW-4

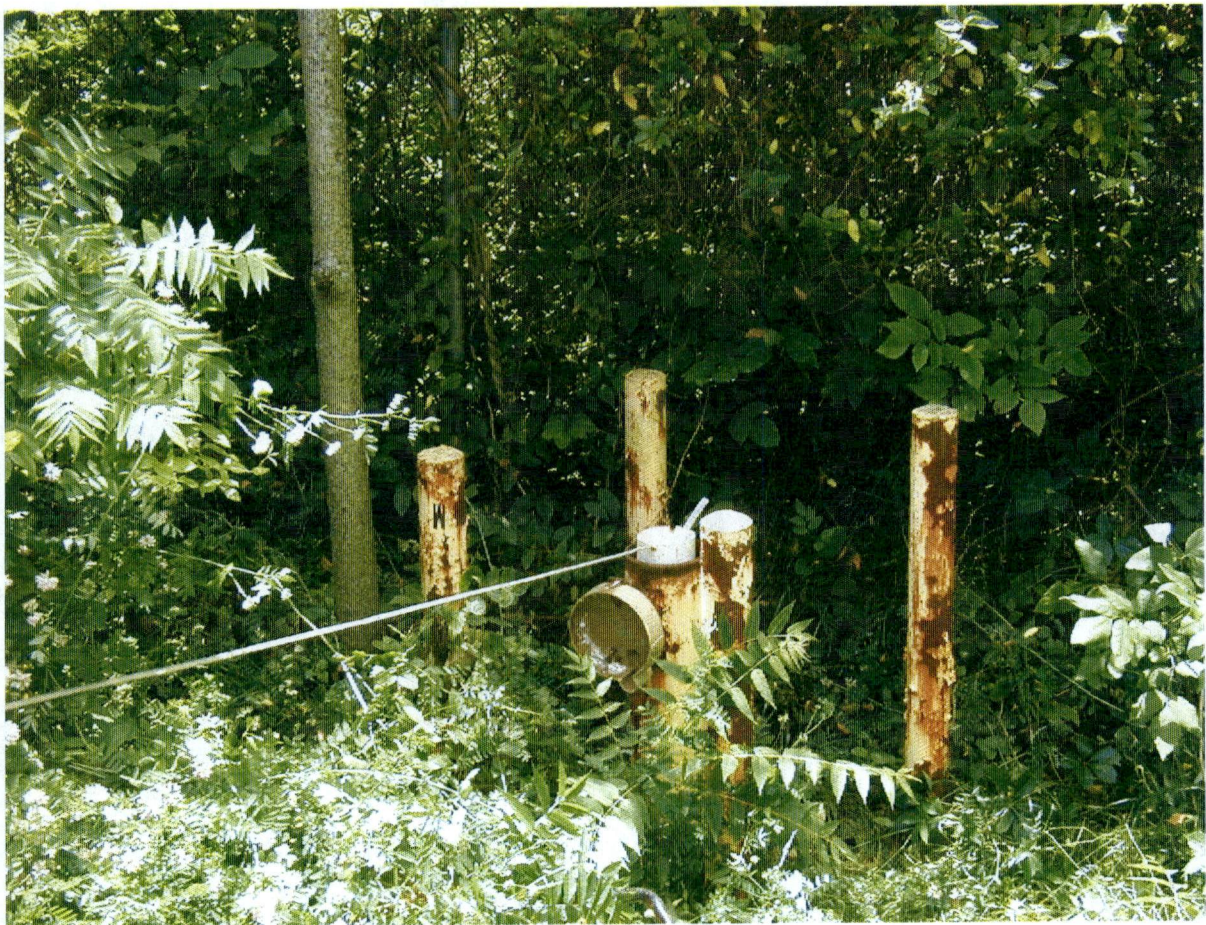
If significant amounts of lead were to be leached from the waste, it would not stay in solution long enough to travel far from the site due to the alkaline nature of the groundwater. Most of the lead that was excavated and consolidated back into the landfill during closure was physically eroded by air or water. Groundwater elevation measurements have been relatively normal. Fluctuations of groundwater levels would certainly increase the possibility of moving material from the landfill since the waste is saturated, however this does not explain the persistent lead in well MW-10A. There have been few other changes at the facility to account for increases in contaminant concentrations at this location.

06/19/2008 Well-10A, purging underway.

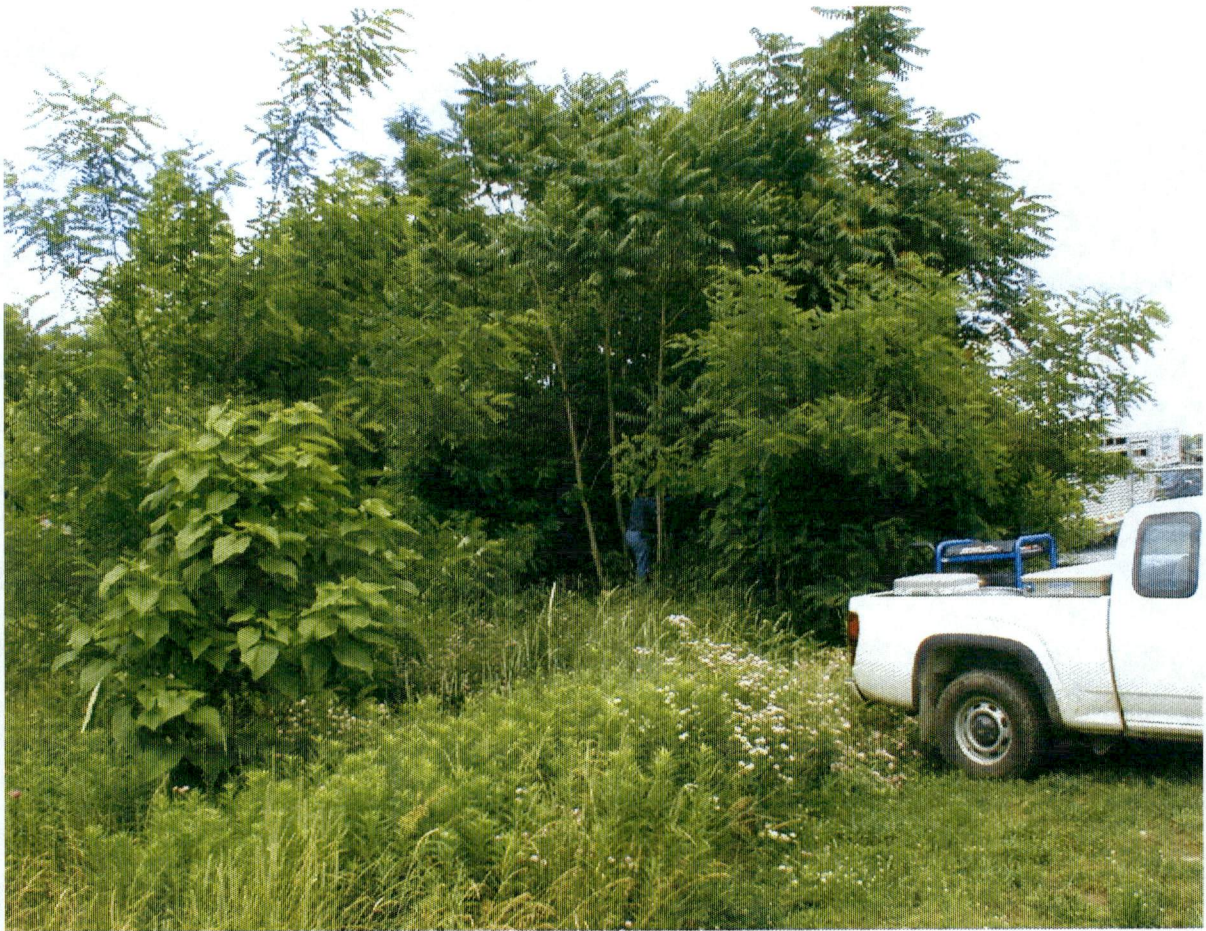
06/19/2008 Location of MW-6 in thicket of trees.

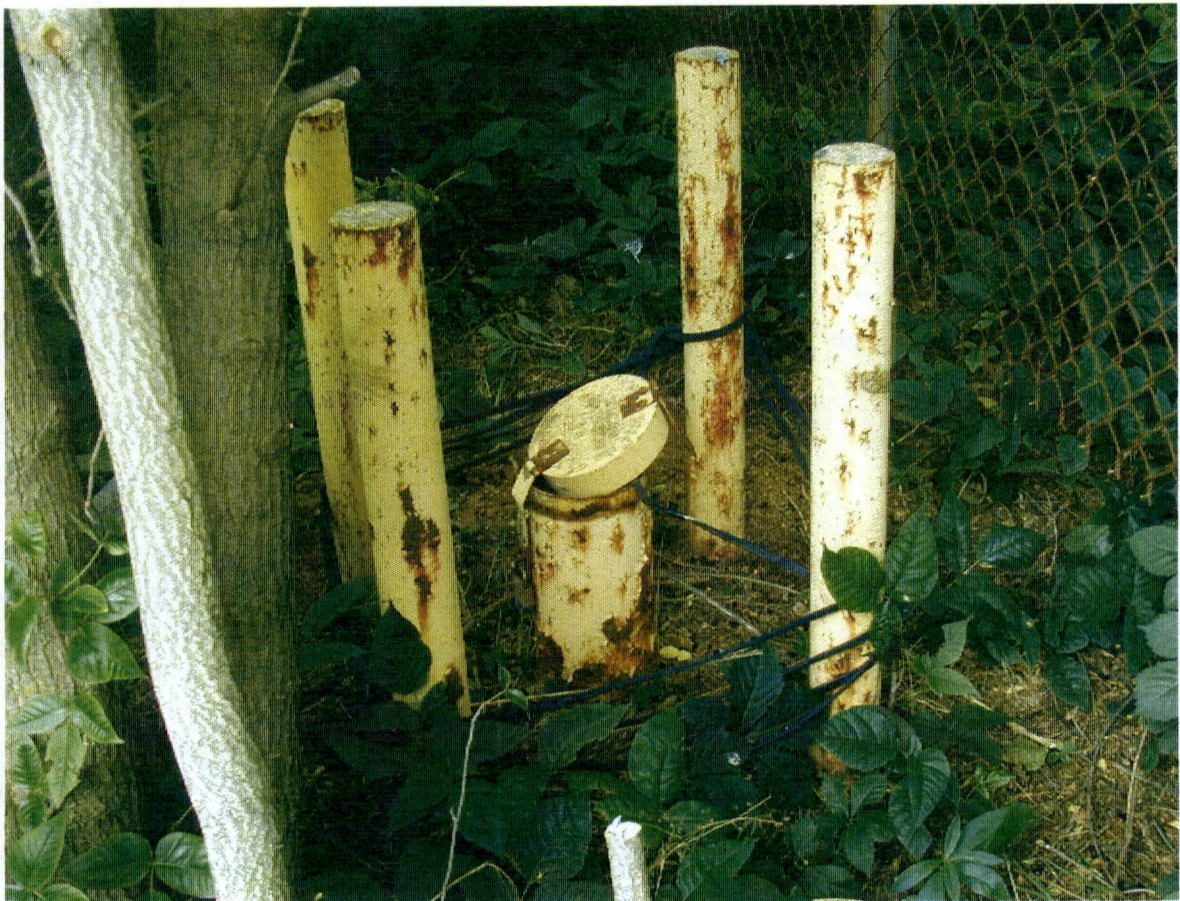
Well outside fence to the West of the paved portion of the facility.
Cap broken and well unlocked. Prolific poison ivy surrounding well.
ORP=155mV. Meter malfunctioning so reading may be unreliable.

06/19/2008 MW-6 in poison ivy, cap broken.
